DUSTLESS BLASTING **CASE** STUDY

REMOVING ANTIFOULING PAINT FROM A 54' VIKING YACHT

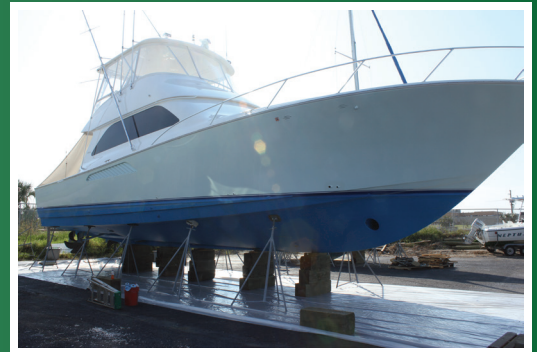
Antifouling paint needed to be removed from this 54 foot Viking yacht, so that a new layer of antifouling paint could be applied. Many blisters had also developed in the fiberglass gelcoat. These blisters needed to be opened up for repair.

Normally we recommend blasting fiberglass at about 70 PSI. However, the main goal of this job was to open blisters in the gelcoat so they could be repaired.

Since gelcoat is tougher than the antifouling paint, we kicked the pressure up to 120-135 PSI.
