CASE STUDY

Strip Paint and Rust from 34' Boat Bottom

Objective: Strip failing coating from 34' boat bottom

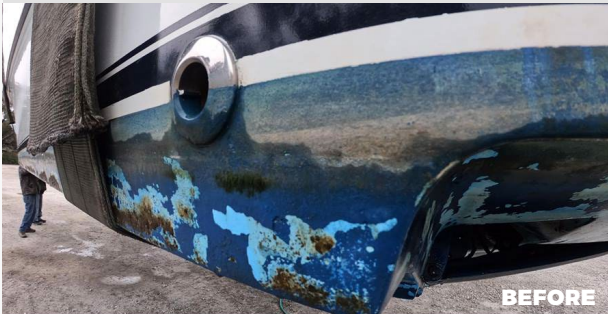
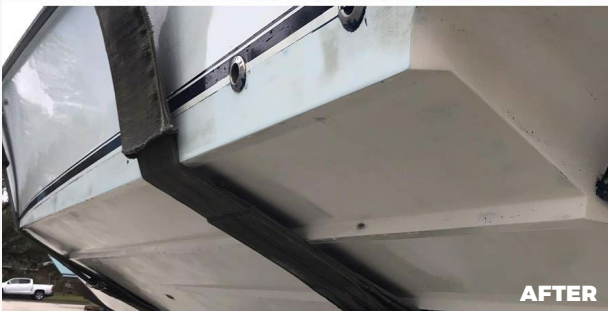
This contractor says that his fan nozzle made a big difference in how quickly he was able to strip this 34' boat. He also wore a Nova 3 blast respirator to stay clean and comfortable while working.

"Two layers of bottom paint melted off with the Dustless Blasting machine. Left the perfect profile for a new layer of bottom paint **that will last.**"
