CASE STUDY

54-FOOT VIKING YACHT

Objectives:

- ✓ Remove antifouling paint to prepare for re-application.
- ✓ Open fiberglass gelcoat blisters for repair.

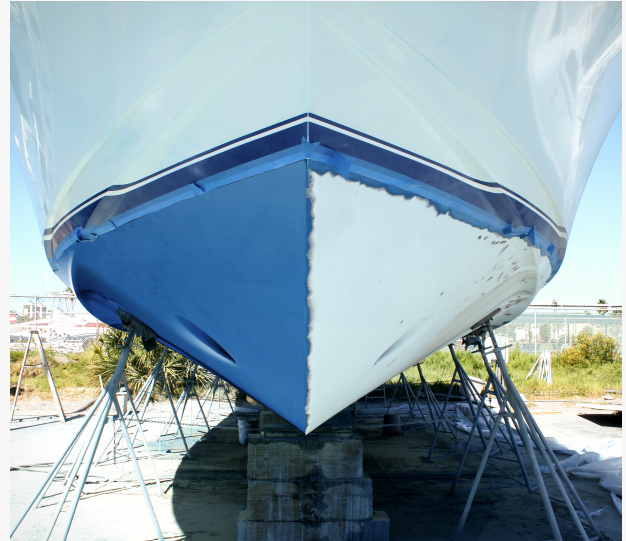
Normally we recommend blasting fiberglass at about 70 PSI. However, to open the blisters in the gelcoat for repair, the pressure was increased to 120-135 PSI.
