# CASE STUDY

## Remove Failing Powder Coating from Rims

**Objective:** Strip failing powder coating from rims

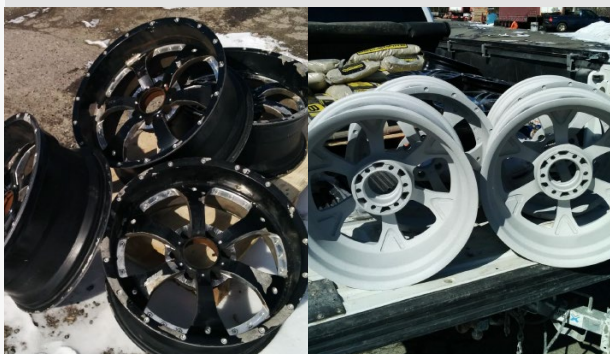
Our mobile Dustless Blasting machines are also capable of dry blasting, which may be necessary when the weather is freezing or below freezing.

Note the snow on the ground – our contractor chose to blast dry in these conditions.

DB500 Mobile

80 PSI

185 CFM

Dry blasting

#5 SLV nozzle

40/70 crushed glass
